DEPARTMENT OF TRANSPORTATION**DIVISION OF ENGINEERING SERVICES**

Contract #: 04-0120F4Cty: SF/ALA Rte: 80 PM: 13.2/13.9File #: 69.28**WELDING INSPECTION REPORT****Resident Engineer:**Pursell, Gary**Address:** 333 Burma Road**City:** Oakland, CA 94607**Report No:** WIR-001965**Date Inspected:** 05-Apr-2008**Project Name:** SAS Superstructure**OSM Arrival Time:** 1800**Prime Contractor:** American Bridge/Fluor Enterprises, a JV**OSM Departure Time:** 730**Contractor:** Zhenhua Port Machinery Company, Ltd (ZPMC), Changxing Island **Location:** Shanghai, China

Bridge No: 34-0006**Component:** Tower**Summary of Items Observed:**

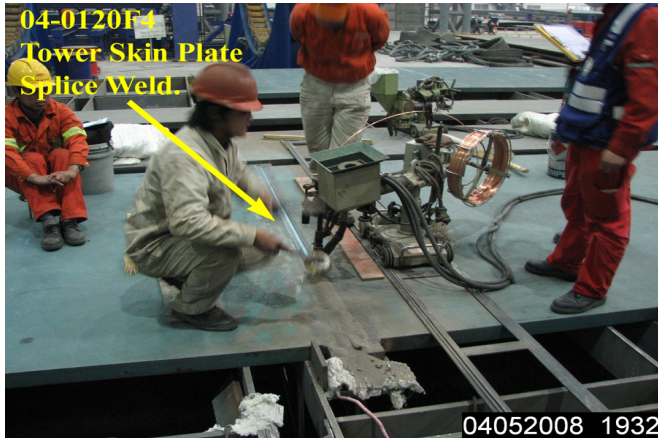
Item Description	WBS	Dwg No.	Status
1 Tower Skin Plate	NA	NA	ZPMC Heat Straightening
New Tower Shop: The Caltrans QA Inspector observed ZPMC performing flame heat straightening operations on tower skin plates for mill distortion. The tower skin plate and heat straightening procedure are identified as skin plate SA49 (W), procedure HSR1 (T) 413, revision (0). Caltrans QA observed ZPMC heating the plate manually with a rose-bud torch. Caltrans QA observed ZPMC Quality Control Inspector, Mr. Yang Ming Ming monitoring the heat straightening of the plate using a calibrated infra-red temperature indicating device to monitor the heat.			
2 Tower Skin Plate	NA	NA	Welding in Progress
New Tower Shop Bay 1: Caltrans QA Inspector observed submerged arc welding (SAW), complete joint penetration (CJP) skin plate splice, fill pass weld. The subassembly is identified as skin plate SA107 (W) to P882 (W), weld location WSD1-SA107 D/J -16A. The welder operator is identified as Mr. Xue Yi An, welder stamp 040634. The welder is observed using welding procedure specification, WPS-B-T-2221-B-U3c-S, revision 1. Caltrans QA measured current welding parameters at approximately 685 amps, 33.0 volts and 620mm/min (millimeters per minute) travel speed. Caltrans QA verified the preheat and interpass temperatures during the welding activities. The preheat temperature prior to the start of welding measures more than 110 degrees Celsius but less than 230 degrees Celsius during maximum interpass temperature verification. Caltrans QA observed ZPMC Quality Control (QC/CWI), Mr. Zhu Zhonghai monitoring the welding activities at the work-station. The following digital photograph illustrates welding in

progress at the work-station.

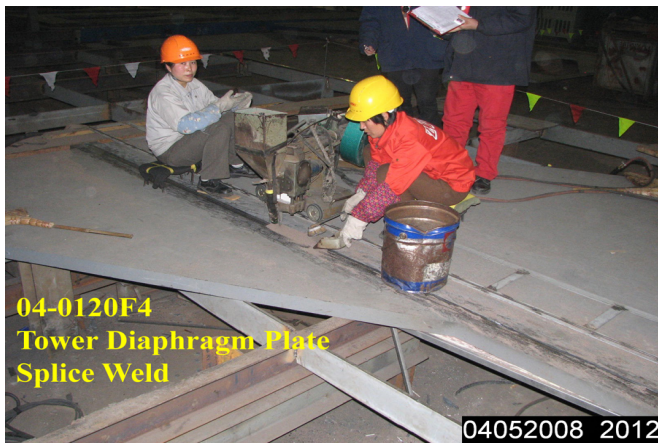
| 3 | Tower Diaphragm Plate | NA | NA | Welding in Progress |

Bay 8: Caltrans QA Inspector observed submerged arc welding (SAW), complete joint penetration (CJP) diaphragm plate splice, fill pass weld. The subassembly is identified as diaphragm plate SA334 (S) to P348 (S), weld location SSD1-SA334 A/B -1B. The welder operator is identified as Ms. Ma Ying, welder stamp 045270. The welder is observed using welding procedure specification, WPS-B-T-3221-B-U3c-S-1, revision 0. Caltrans QA measured current welding parameters at approximately 620 amps, 31.0 volts and 490mm/min (millimeters per minute) travel speed. Caltrans QA verified the preheat and interpass temperatures during the welding activities. The preheat temperature prior to the start of welding measures more than 180 degrees Celsius but less than 230 degrees Celsius during maximum interpass temperature verification. Caltrans QA observed ZPMC Quality Control (QC/CWI), Mr. Ye Yong jun monitoring the welding activities at the work-station. The following digital photograph illustrates welding in progress at the work-station.
